Prepared for the Tulsa County Board of County Commissioners

# Conditions Assessment Report Review

TULSA COUNTY COURTHOUSE RENOVATION

January 24, 2023

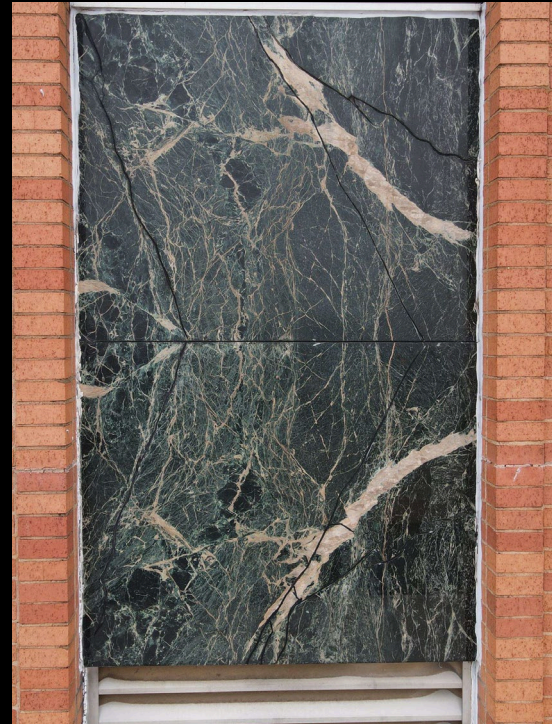
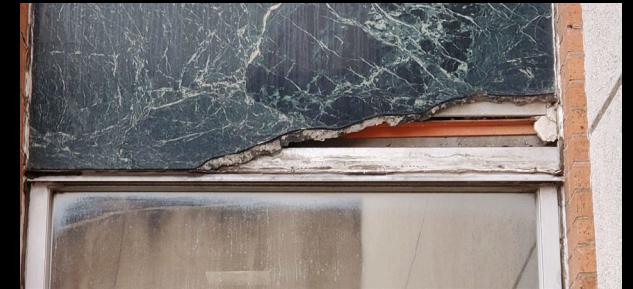
Marble Panel Location Diagram

**THE MARBLE PANELS ARE FAILING ACROSS ALL INSTALLED LOCATIONS AND NEED TO BE REPLACED**

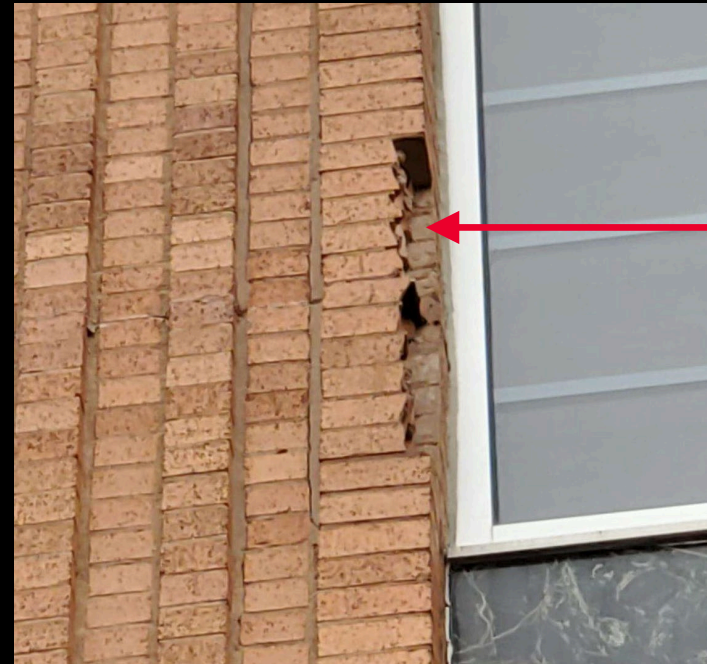
Brick Façade Location Diagram

**BRICK FAILURES**

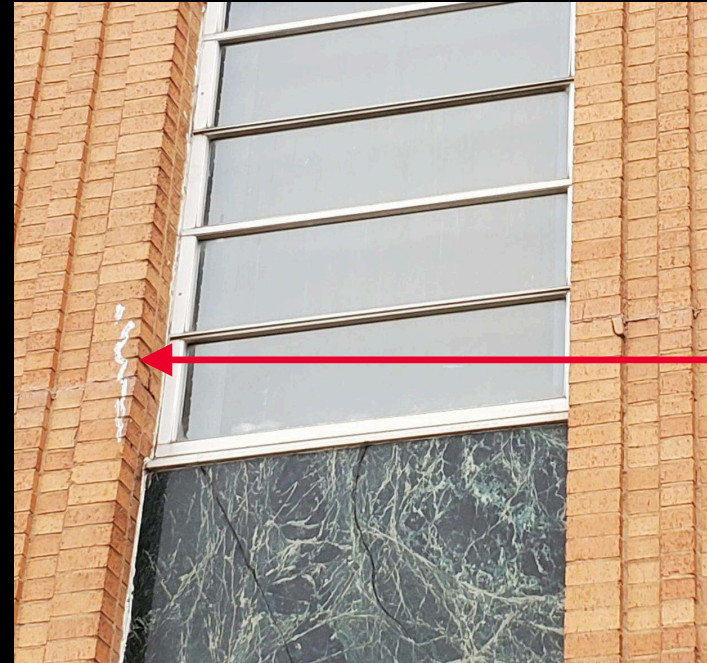
Brick Façade Location Diagram

**BRICK FAILURES**

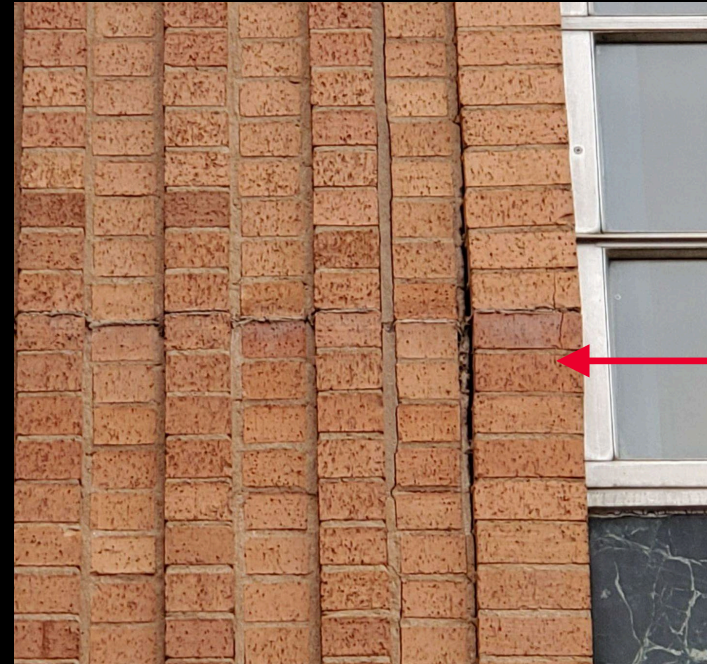
## Brick Façade Location Diagram

**BRICK FAILURES**

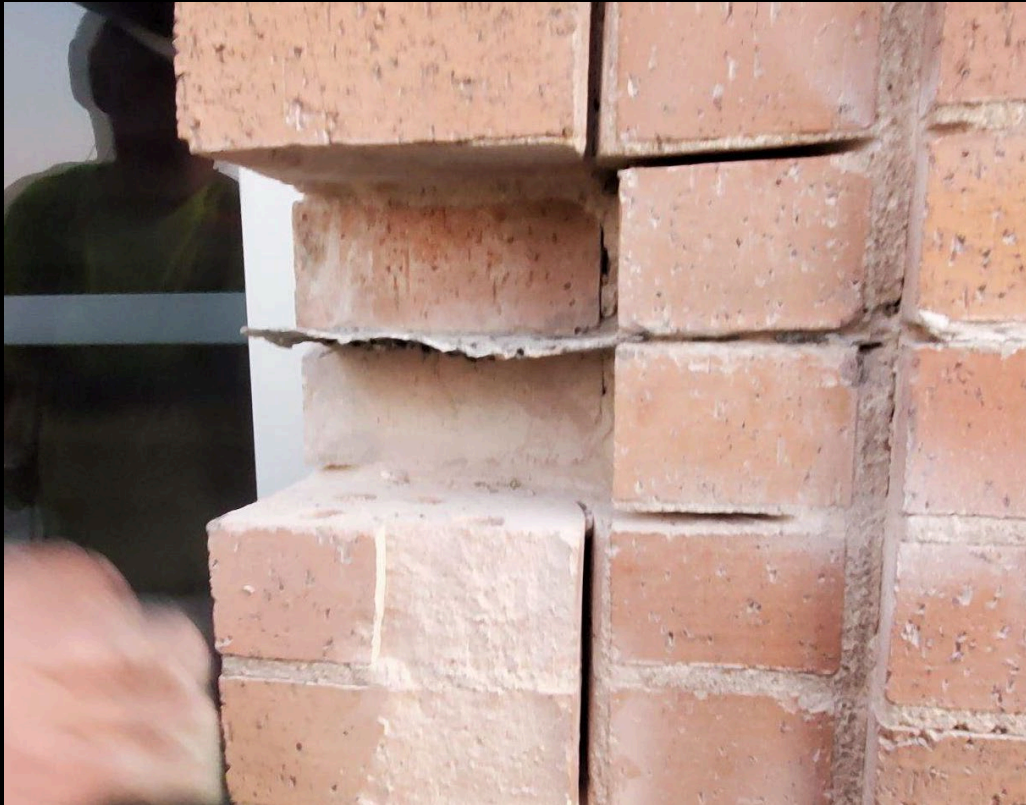
### Uncovered Expansion Joint Material

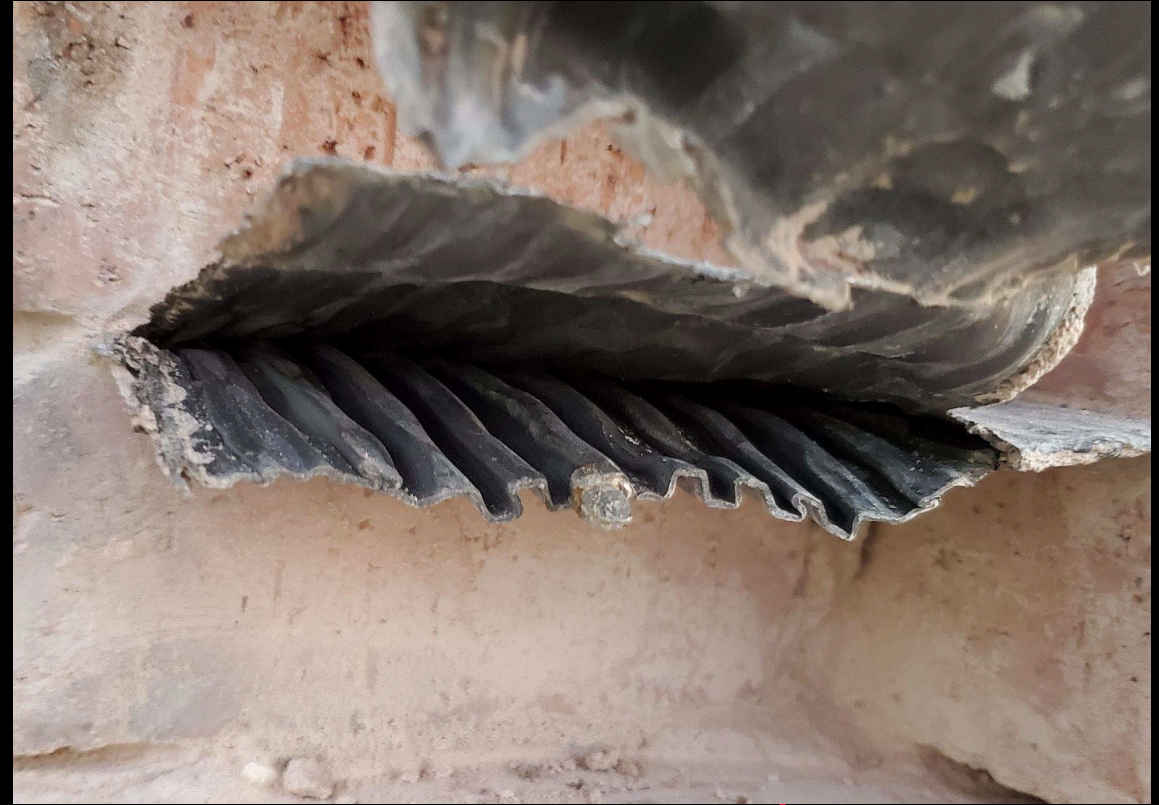
### Peeled Back Expansion Joint Material

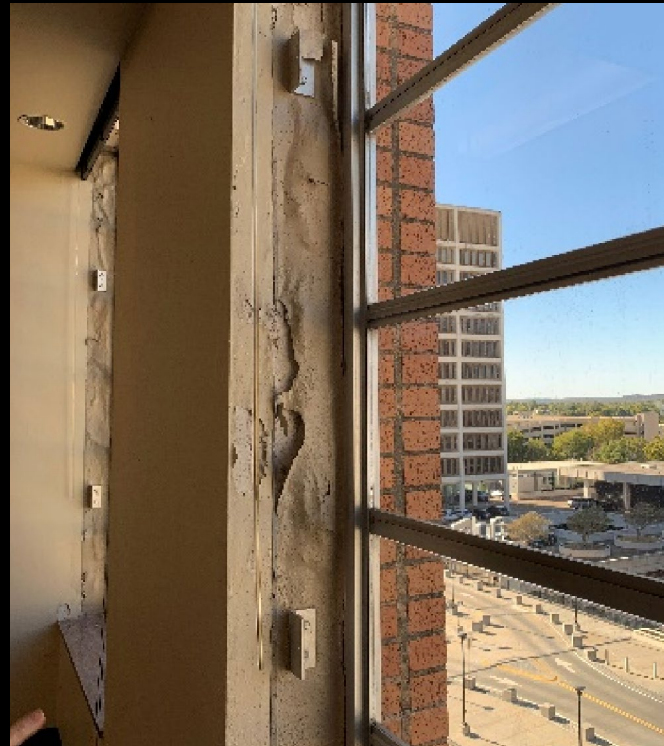
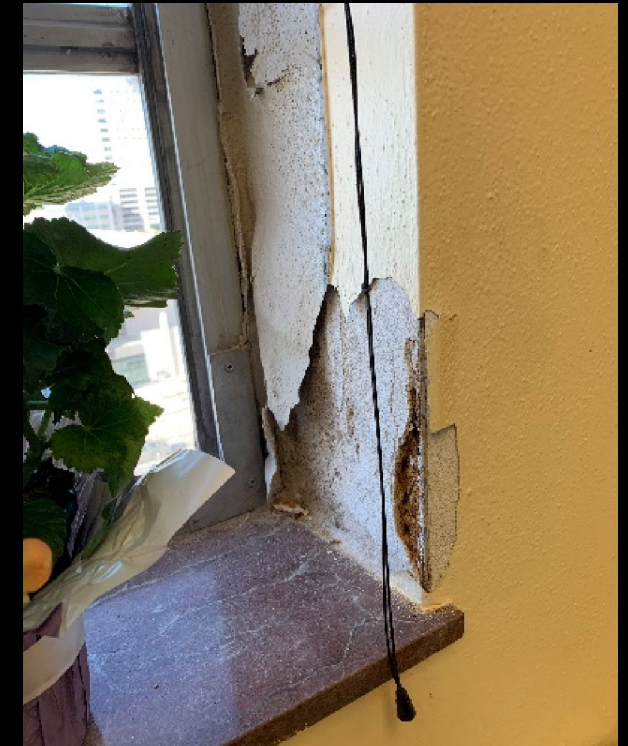
Water Damage Photos

THE POTENTIAL FOR UNOBSERVED  
OR "HIDDEN" MOLD IS ELEVATED  
AND WILL BE ELEVATED UNTIL THE  
COURTHOUSE CAN IMPROVE THE  
BUILDING ENVELOPE  
WATERPROOFING

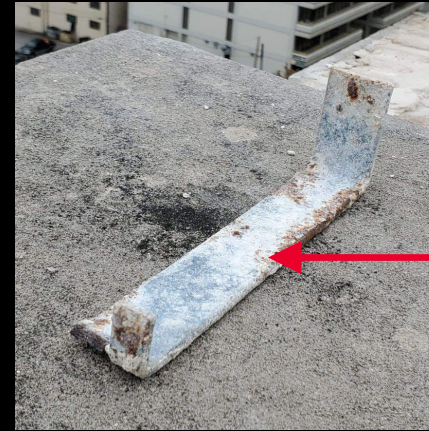
Galvanized Steel  
Stone Anchors

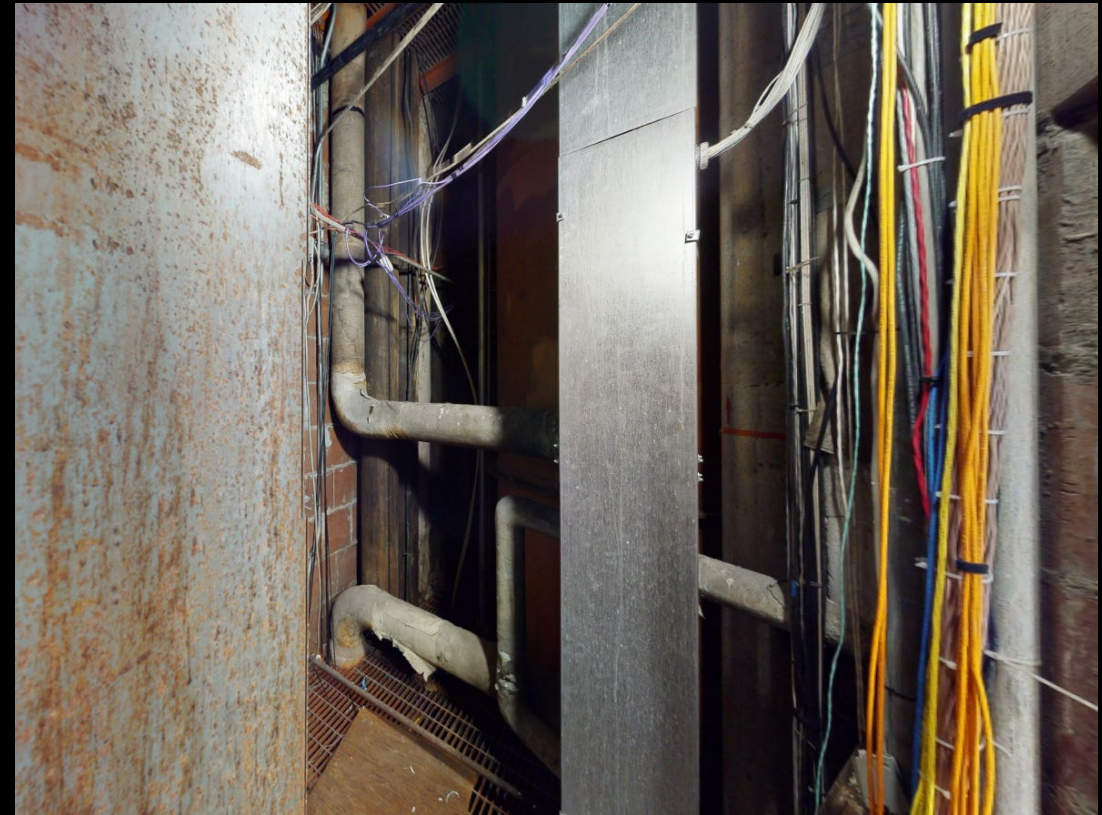
**EXISTING SHAFT INTERIOR**

- ADD ONE (1) SERVICE SIZE ELEVATOR IN WHAT IS CURRENTLY A VENTILATION SHAFT.
