Prepared for the Tulsa County Board of County Commissioners

# Conditions Assessment Report Review

TULSA COUNTY COURTHOUSE RENOVATION

January 24, 2023

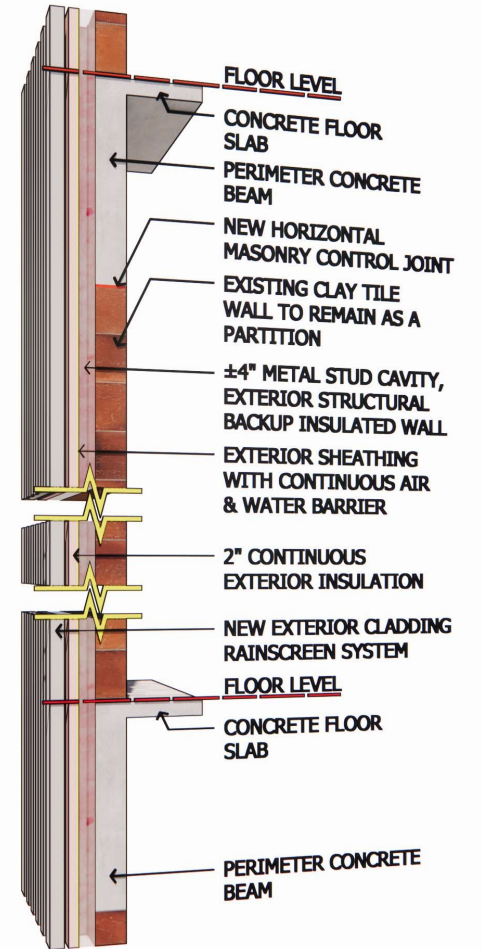
### BRICK PILASTER / OPTION A - REPLACEMENT

- Modern structural performance
- Improved thermal performance
- Continuous air and water barrier
- Vented rainscreen maximizes the wall's outward drying potential.
- Long-term solution
- Update building appearance.
- Prevents moisture wicking into the interior through wall at window jambs

- Cost
- Construction time / disruption

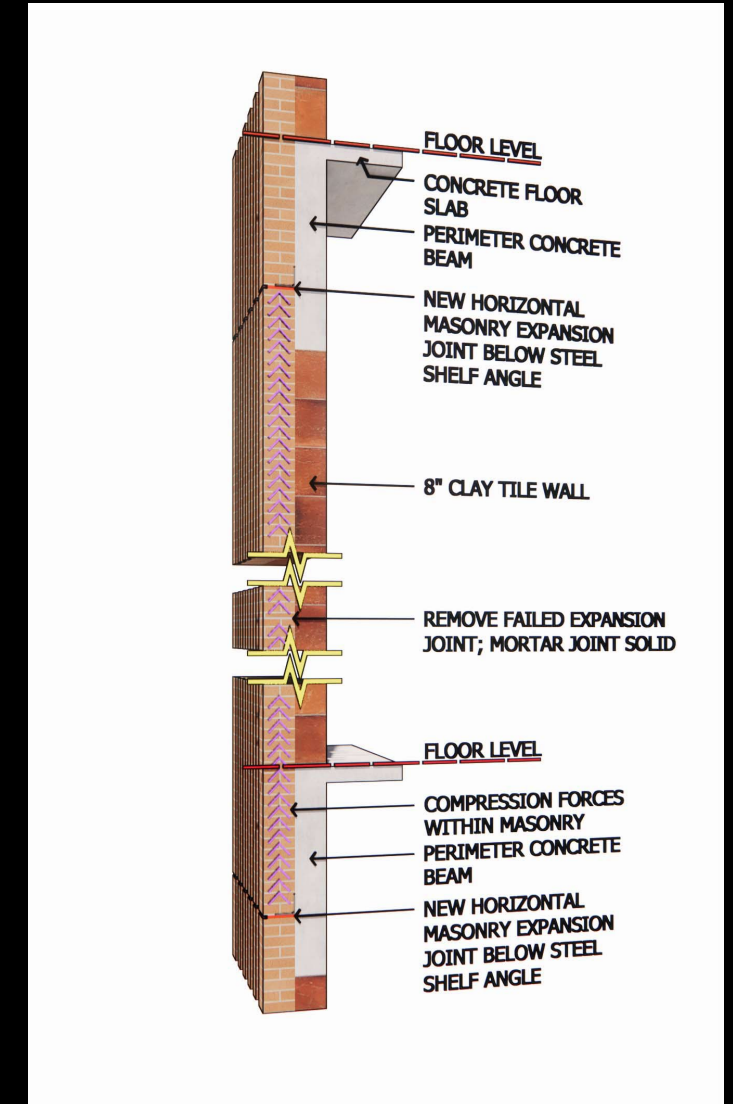
### BRICK PILASTER / OPTION B - REPAIR

- This may be a more affordable option and improves the current failing elements of the assembly.
- Maintains appearance and original materials.

- A water repellent can be applied however, the inherent risks of moisture migration of this assembly will remain.
- Supplemental retrofit ties may be needed to connect the existing brick to the clay tile back up wall which may not have the capacity for them.
- Unforeseen conditions and hidden conditions, such as galvanized corrugated tie corrosion, will remain risks.
- No thermal improvement to assembly.
- No control joint at inner clay tile wall
- To ensure color match, existing brick will need to be cut to provide for new expansion joint.

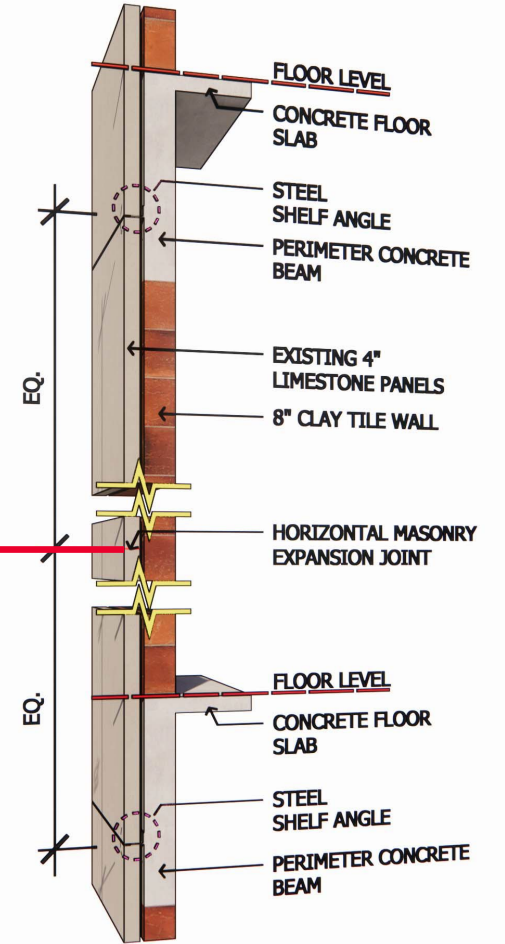
Galvanized Steel  
Stone Anchors

- A water repellent can be applied however, the inherent risks of moisture migration of this assembly will remain.
- The galvanized steel stone anchors will continue to corrode when exposed to moisture until ultimate failure.
- Unforeseen conditions and hidden conditions will remain risks.
- No thermal improvement to assembly.
- No control joint at inner clay tile wall.

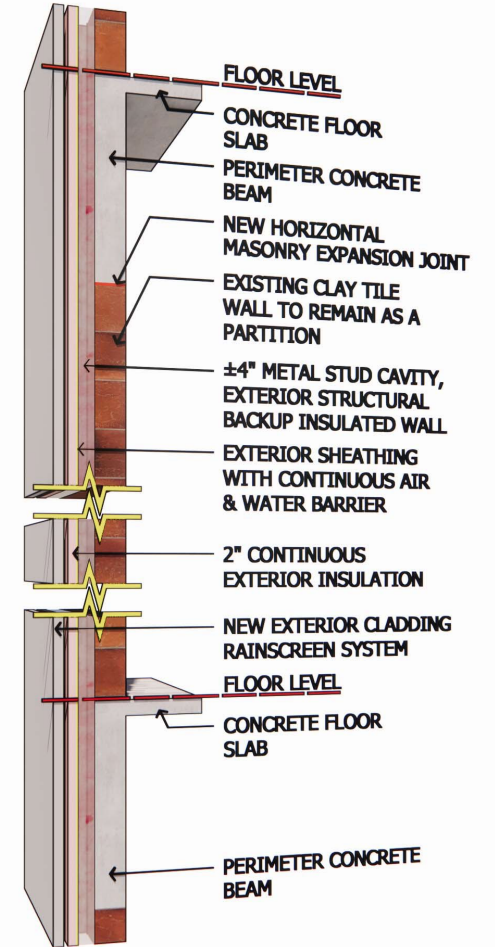
### LIMESTONE PANEL / OPTION A - REPLACEMENT

- Modern structural performance
- Improved thermal performance
- Continuous air and water barrier
- Vented rainscreen maximizes the wall's outward drying potential.
- Long-term solution
- Update building appearance..

- Cost
- Construction time / disruption

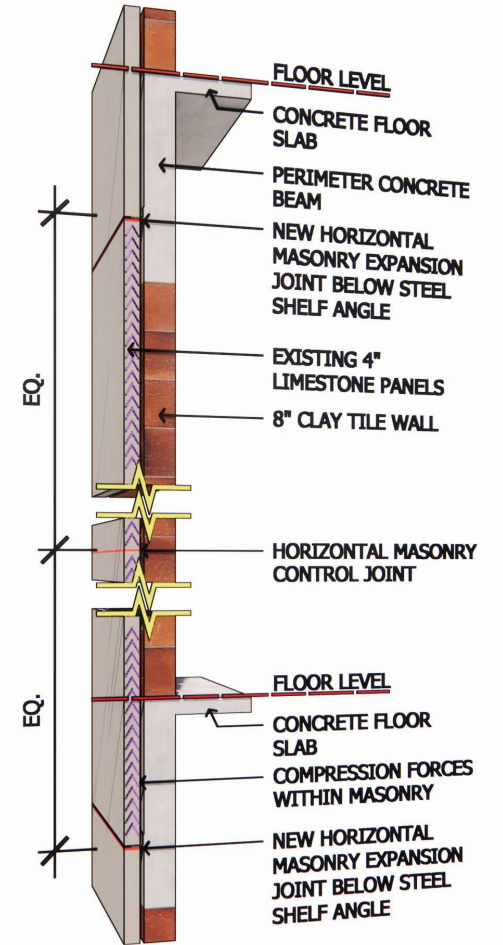
### LIMESTONE PANEL / OPTION B - REPAIR

- This may be a more affordable option and improves the current failing elements of the assembly.
- Maintains appearance and original materials.

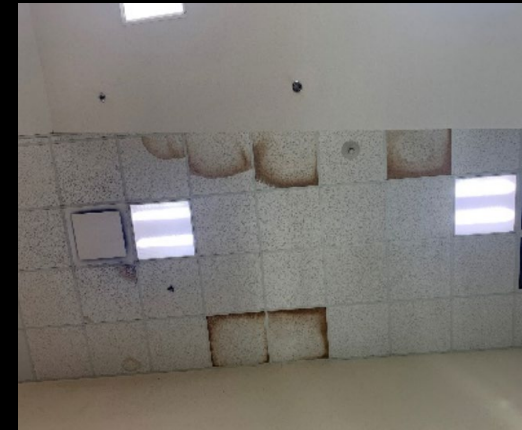
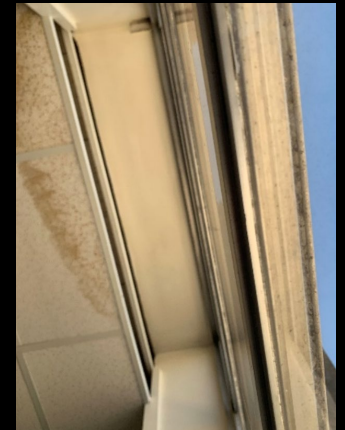
- GENERAL INDOOR AIR QUALITY CONSIDERED TO BE ACCEPTABLE TO EXCEPTIONAL.
- ALL AREAS WERE NOTED AS BEING FREE FROM ODORS AND MOVEMENT OF AIR WAS NOTED.
- RECOMMENDS REPLACING DAMAGED ACOUSTIC TILE.
- KEEP SUPPLY AND RETURN VENTILATION FIXTURES CLEAN.

- FAÇADE LEAKS ARE MENTIONED SEVERAL TIMES IN REPORT.
- GIVEN THE POTENTIAL FOR WATER TO MOVE INTO THE BUILDING, THE POTENTIAL FOR UNOBSERVED OR "HIDDEN" MOLD IS ELEVATED AND WILL BE ELEVATED UNTIL THE COURTHOUSE CAN IMPROVE THE BUILDING ENVELOPE WATERPROOFING AND ROOFING.
